HAIL DAMAGE DOCUMENTATION

# HAIL DAMAGE DOCUMENTED ROOF TO GROUND

## Ashley Furniture Warehouse

2609 W COLLEGE AVE · NORMAL, IL 61761  
DATE OF LOSS MAY 15, 2025 · INSPECTED JUL 8 – OCT 5, 2026

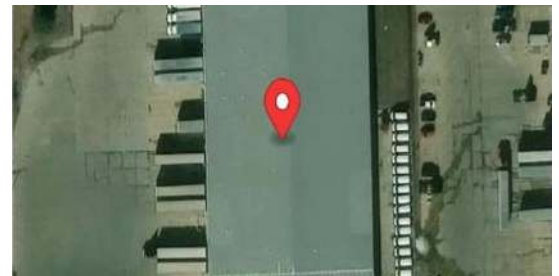
HailTrace satellite tile for 2609 W College Ave. It shows this building (west loading docks, long metal roof).

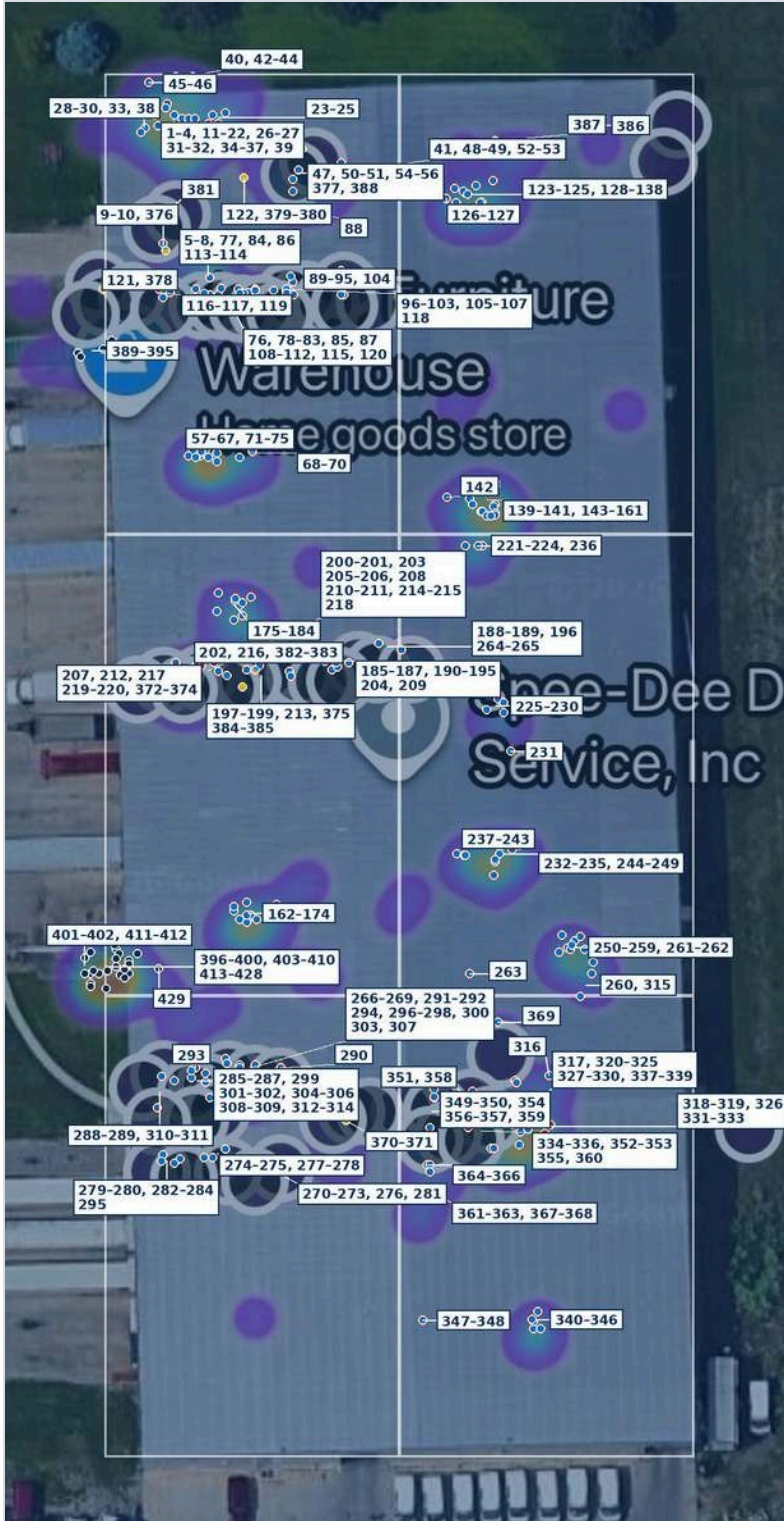
Every photo number sits at its pin. Photos taken within a few feet of each other share one label, with a leader line to the spot.
